COMPONENT RELIABILITY ASSESSMENT

SYSTEM: W31-3 Warhead

MAJOR ASSEMBLY: Firing Set Assembly

COMPONENT: Strong Link Switch

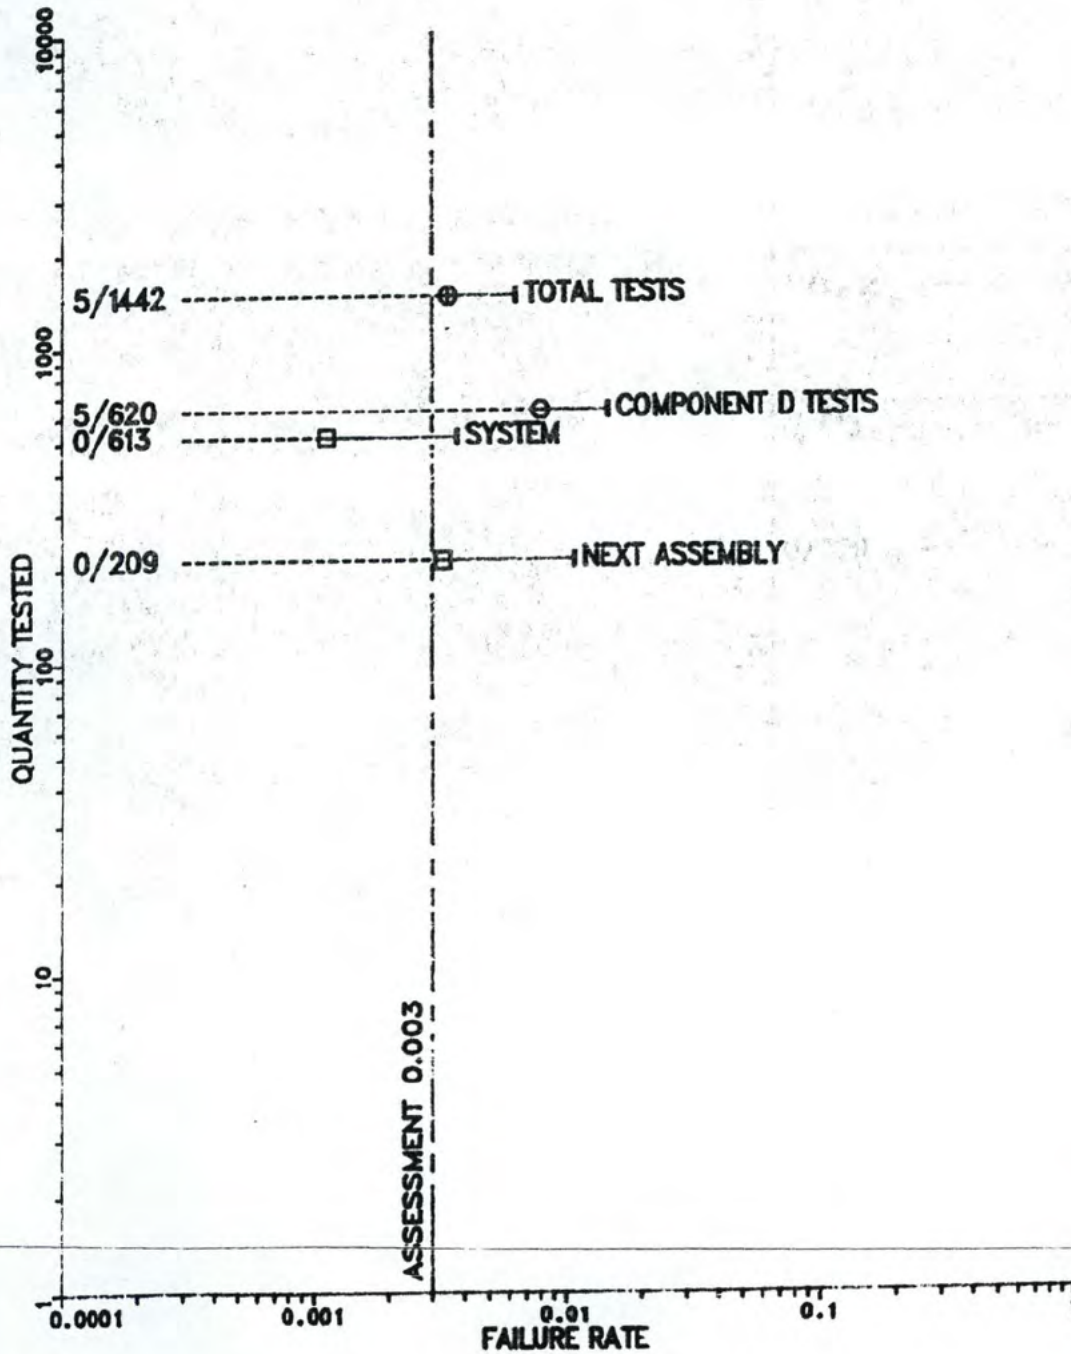
DATA-ASSESSMENT COMPARISON CHART

at 0.003. The Data-Assessment Comparison Chart presents a visual comparison of the data used to assess Event J6.
